**Mr. WATER**  
PROFESSIONAL WATER TREATMENT™  
Hagerstown, MD 21740

Patent Pending Water Softener and Sulfur (Hydrogen Sulfide) Removal System

## Custom Water Conditioning Equipment

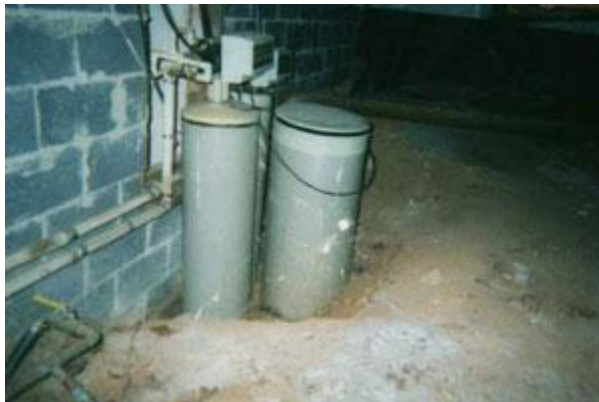
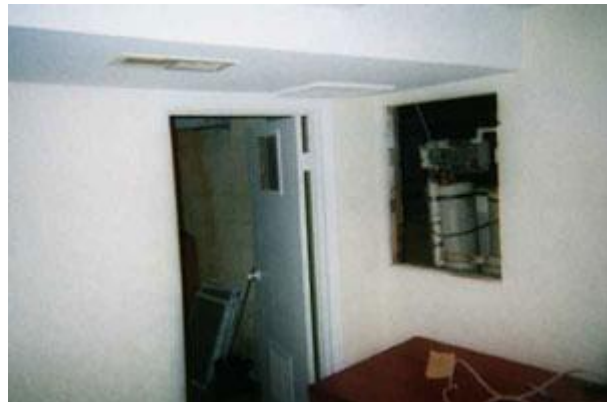
These are pictures of a **Culligan**® acid neutralizer, water softener and brine tank installed in a nearly inaccessible crawlspace. Water treatment systems installed in this manner make it very difficult to service and maintain; imagine having to move around on your hands and knees (because you can't stand-up) with 50 lb. bags of salt to fill your brine tank. Not only is it hard for the homeowner – it's tough for the service technician too. Equipment installations not thought out and poorly installed are an invitation for failure. This system had not been serviced for years and was leaking under the house. In the picture on the right, the doorway to the mechanical room is where we professionally installed the new **EcoSoft Water Treatment Systems**™.

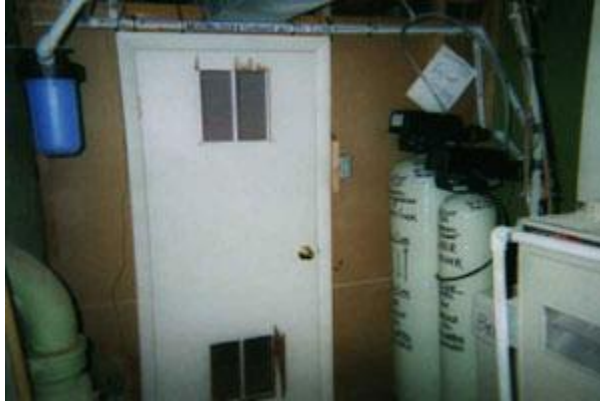
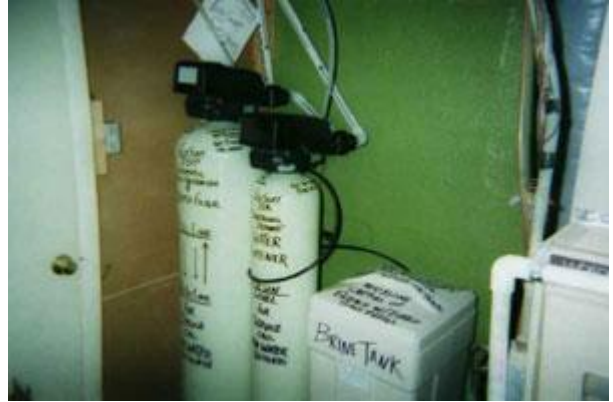
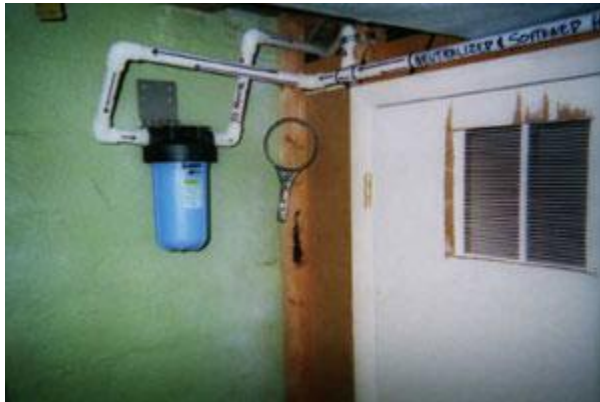
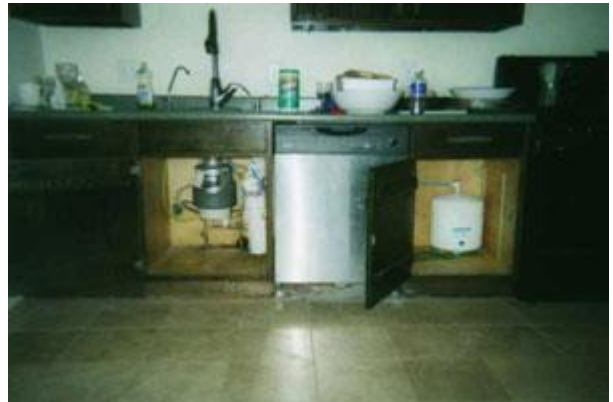
Mr. Water™ Professional Water Treatment installs its systems the right way! Not only are these units going to be much easier to service and maintain, their no longer subject to freezing weather or dirty and dusty conditions. The first picture is a wide angle view of the system. The next is a close-up of the **EcoSoft Water Treatment Systems™** “Automatic” acid neutralizer with 6 day time clock, and “Electronic Demand” water softener with its brine tank. The third is a whole house “Big Blue” post filter with wrench and carbon cartridge for taste and odor removal. This customer also elected to install a Mr. Water™ 5 Stage Reverse Osmosis System. The R.O. system was installed with the pure water holding tank in an adjacent cabinet because the garbage disposal was in the way. Installed for a very grateful customer in Bethesda, MD 20817.

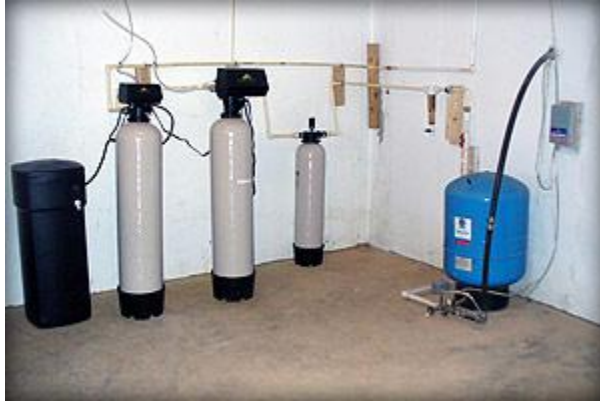
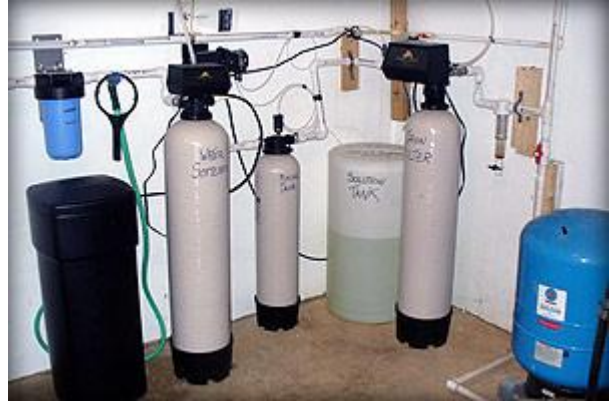
This customer found our website and decided to see if we could help. The picture on the left is the **TurboSoft**<sup>®</sup> iron filter, water softener, air injection system and sediment strainer that was incorrectly installed by a local plumber. Not only was the micronizer (air injector) placement incorrect, the air release valve in the top of the mixing tank was broken. The water still smelled like sulfur (rotten eggs) and the pressure in the house was very poor. The photo on the right is the system professionally reinstalled using the existing mixing tank for the new chlorine chemical feed pump with automatic flow switch. With the micronizer removed, and 1" PVC piping, - water pressure greatly improved. The smelly water is gone now, and this customer has the added benefit of chlorine disinfection without the chlorine taste because we also installed a Big Blue GAC (carbon) filter last in sequence. We also re-bedded the iron filter with the proper media. These customers had their water fixed in Gerrardstown, WV 25420.

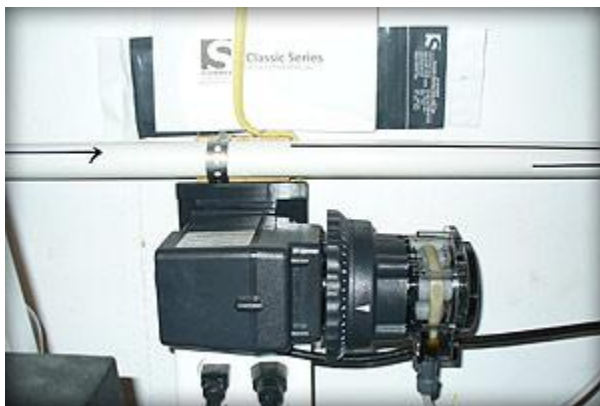
**Stenner**<sup>®</sup> peristaltic chemical feed pump, manual and replacement tube.

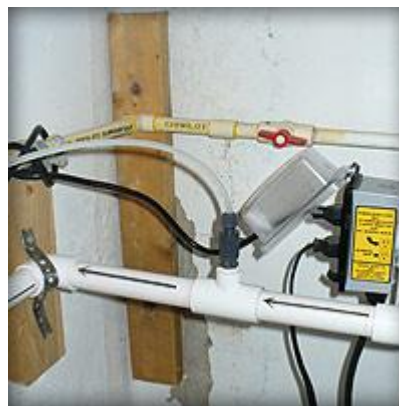
Solution injector and flow switch for chlorine feed pump system.

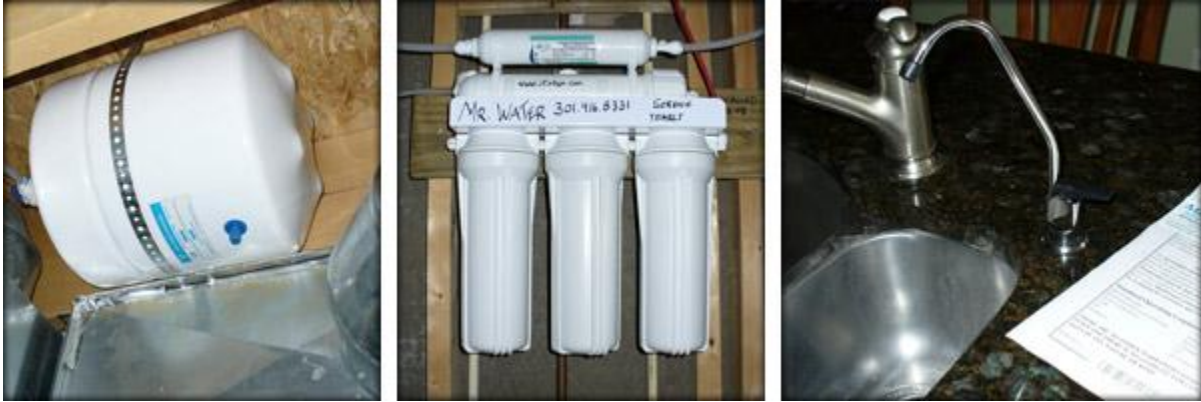
These are pictures of a 5 stage Mr. Water™ Reverse Osmosis System installed in the customers' basement. The system filters and membrane are hanging on the wall; the holding tank is installed between the floor studs up and out of the way, and the pure water faucet is installed in a nice granite kitchen countertop. We also have the icemaker and cold water dispenser on the refrigerator getting great tasting and healthy R.O. water. When possible we like to install R.O. systems in the basement because it gives the customer much more room under the kitchen sink and the system is easier to service. This customer has 11ppm of nitrates and is selling the house. Installed in Sykesville, MD 21784.

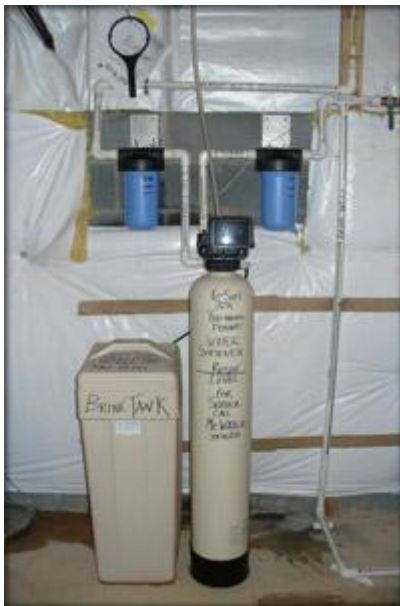
A website is a very nifty way to showcase a company's projects and services –and this customer found us in cyberspace. "It was all of the pictures of your systems in the homes of others that prompted me to call" stated this customer to our technician. Irony water was the problem this family found when they moved in to their new home. Brand new tubs and sinks were starting to get stained brown from the water; they couldn't do laundry, and they said the water tasted like a rusty nail. They opted for our standard **EcoSoft Water Treatment Systems™** 32,000 grain

water softener with 30 micron prefilter and GAC (carbon) postfilter for taste and odor. This system will easily handle the 2ppm of iron in their well water; it will also remove radium if it shows up. Another customer got their water fixed in Severn, MD 21144.
